ELECTROCHEMICAL AGING EFFECTS ÎN PHOTOVOLTAIC MODULES

JET PROPULSION LABORATORY

G. R. Mon

Electrochemical Corrosion of Photovoltaic Modules: A Review

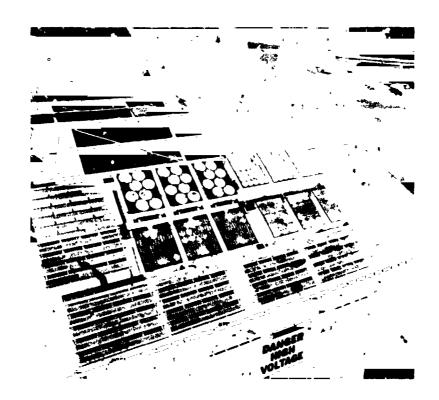
PVB-Encapsulated Modules Arranged on Outdoor Test Stand
